PUBLISHED BY FORD MOTOR COMPANY OF CANADA, LIMITED, FORD, ONTARIO, CANADA

JANUARY, 1925

Vol. 6

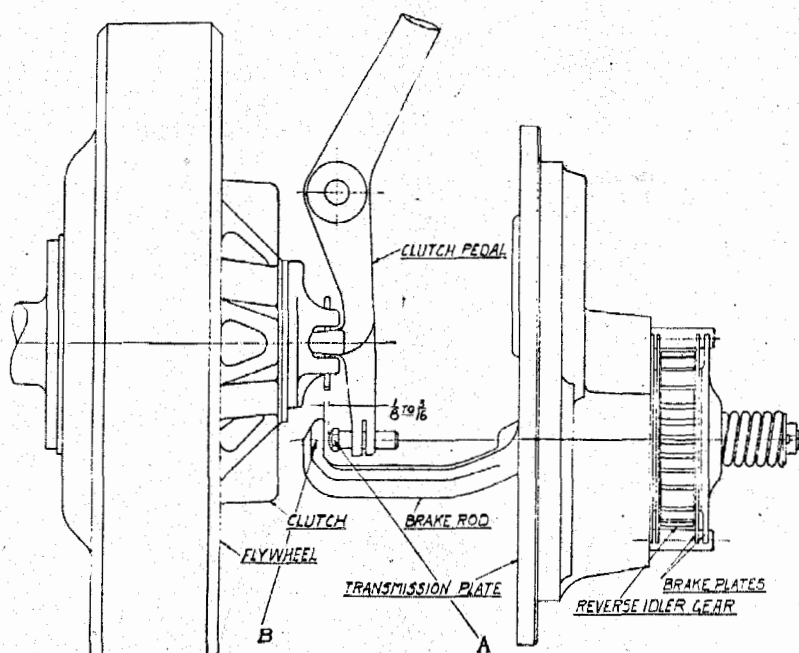
Fig. 41

Remove the foot plate which is located on the right side of the transmission, and expose the adjusting screw "A," Fig. 41, located at the lower end of the clutch lever. It is extremely important that this screw be adjusted so that a gap of not less than $\frac{1}{8}$ " or more than $\frac{3}{16}$ " is obtained between the head of the screw and the upturned lug "B" on the brake shaft.

Failure to do this will cause the brake to drag, resulting in excessive wear of the plates.

It is absolutely essential that this clearance be maintained in order to allow some movement of the clutch pedal to throw out the clutch before bringing the brake into operation.

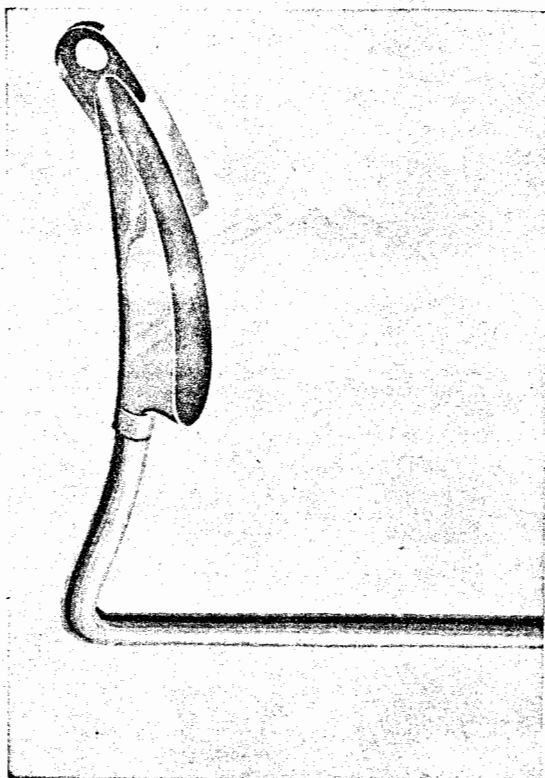
Fig. 42—New

An engineering change was recently made in the crankcase oil tube changing the length of the funnel from $1\frac{1}{2}$ to $3\frac{5}{8}$ ". Figs. 42 and 43 shows the difference in the size of the old and new design oil tubes.

This improvement permits the new design funnel to collect and deliver to the front end of the motor approximately twice as much

oil as was possible with the old style. This is especially advantageous when travelling in mountainous country where steep inclines are frequently encountered. Also, during cold weather when the oil has become congealed and the oil flow is necessarily slow when the engine is started, the larger amount of oil collected by the new type funnel insures the oil reaching the front end of the motor con-

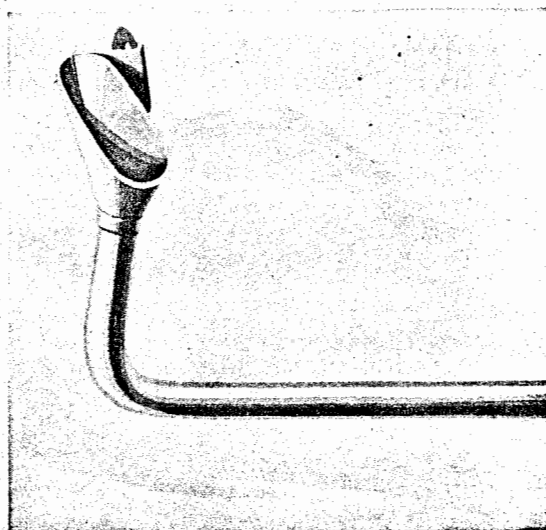
Fig. 43—Old

siderably more quickly than would be possible with the old design.

This change also decreases any possibility of clogging of the oil pipe as the additional amount of oil which is collected by the new funnel increases the oil pressure in the pipe sufficiently to carry away any foreign matter that might accumulate.

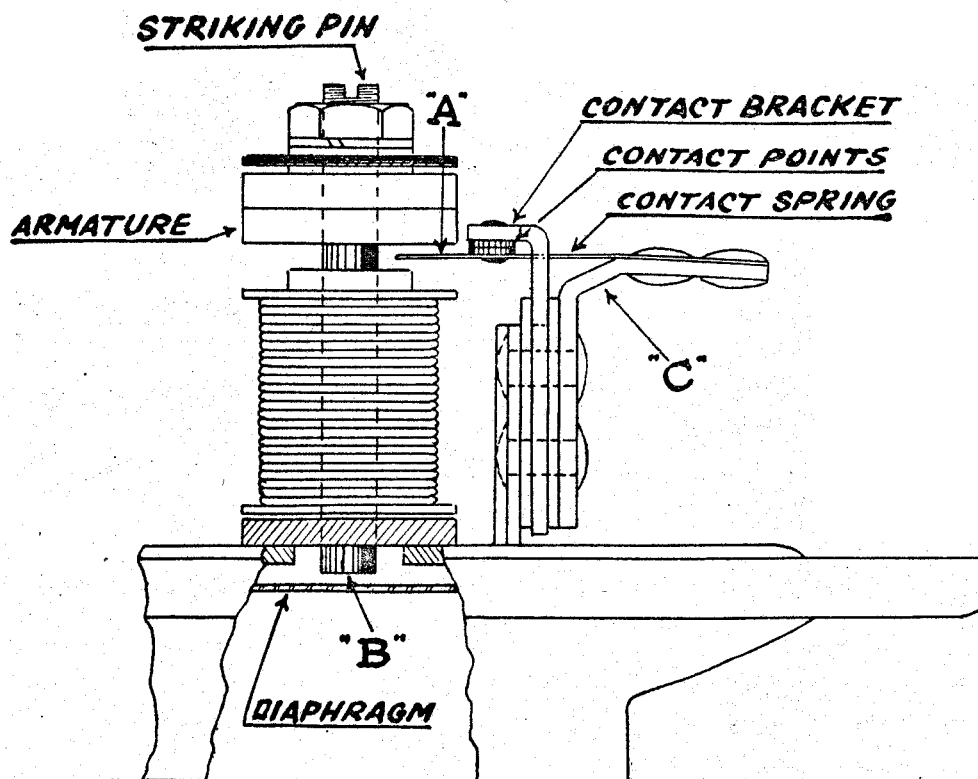
Fig. 45

Figure 45 illustrates one type of electric horn used on a Ford car and although we use two different types the adjustment and operation are almost identical. The armature and contact spring at "A" must be separated from .010 to .020". This distance may be adjusted by bending the end of the contact bracket. The striking pin should be adjusted so that the armature at "A" touches contact spring just before end of striking pin at "B" touches diaphragm. Contact spring support should be bent down at "C" to give slight pressure on contact points. To be sure that contact points line up properly a narrow flat nose plier should be used for adjustment. In the past we have received a large quantity of horns which were returned to us as being defective, but upon examination were found to only need a slight adjustment which could easily have been made. By following the instructions given herewith you should be able to adjust the horn and not whether it is actually defective or not before returning it to the Branch. If the customer is not satisfied with the tone of his horn this can be adjusted within certain limits by loosening the nut at the top of the striking pin and screwing the pin down with a screw driver until the desired tone is produced.
