BY FORD MOTOR COMPANY OF CANADA, LIMITED, FORD, ONTARIO, CANADA

AUGUST, 1925

Vol. 7

No. 3

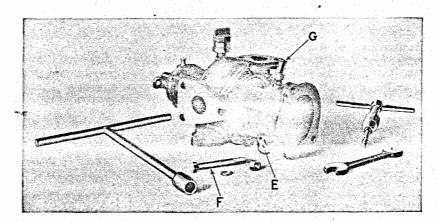
Fig. 44

The new type generator clutch "A", Fig. 45 with which all cars now being shipped from the factory are equipped, is designed to give quieter operation under all conditions. Its construction is such that it does not make a clicking sound when the ignition switch is turned "ON" or when the engine is idling.

To provide adequate lubrication an elbow (E) is to be placed in the overflow hole in the lower back side of the water pump cover. See Fig. 44. An overflow hole at this point is necessary as it establishes a safe level for the lubricant and prevents building up a pressure with the lubricator gun which would force lubricant through the front starter-generator bearing and into the starter-generator where it might get to the commutator and brushes and thus cause serious damage. However, it has been found that this lubricant level can be raised somewhat and that the lubricant is retained longer if the overflow hole is trapped. Both of these objects are obtained by the use of the special elbow L-9168-R in the old overflow hole.

The old style clutch was lubricated through the front oiler on the starter-generator. The new style clutch also receives lubrication through the lubricator connection (G) Fig. 44.

To install a new style clutch the procedure outlined below should be followed:

The generator clutch should now be removed. Disconnect the storage battery and push in the starter pedal. This will lock the starter generator armature so that the screw holding the clutch can be removed. If the starter does not mesh, revolve the starter generator armature slowly until the gears mesh. Remove the clutch using Puller (15Z-12121) 5Z-891.

Put the new style clutch in place and use the special washer (C) in place of the tongued washer (D). The same screw and lock washer

To install the elbow, carefully hand tap the overflow hole with a $\frac{1}{8}$ " pipe tap so that threaded end will not project more than $\frac{1}{8}$ inch above inside of housing. No drilling will be necessary. Remove the clamp screw (F) and screw in the elbow until tight, and shank stand vertically. See Fig. 44. In some cases it may be necessary to file off the corner of the clamp screw boss to clear the elbow as it is screwed in.
