## Crankcase Aligning Jig

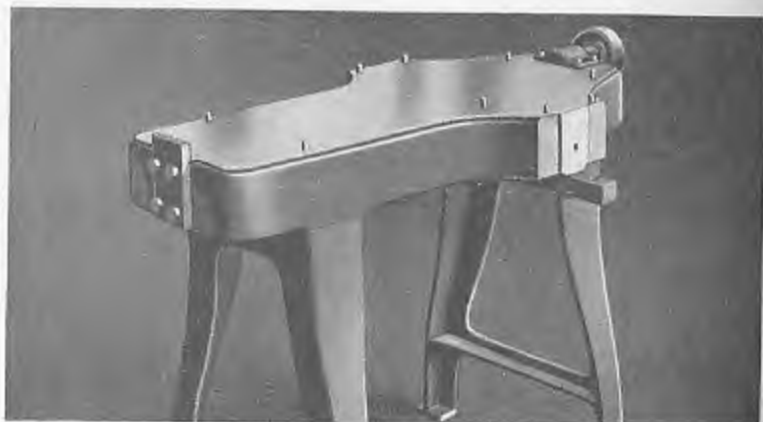
*Fig. 304*

Sometimes a main bearing knock or excessive motor vibration can be traced directly to a bent or sprung crankcase.

A crankcase which is sprung invariably throws the transmission shaft out of alignment and as the transmission shaft is firmly bolted to the flange of the crankshaft it is in reality an extension of that shaft, consequently any misalignment is bound to affect the operation of the motor.

A crankcase aligning jig (see Fig. 304) provides a quick and accurate method of checking the crankcase. (Before checking the case it should be thoroughly cleaned, making sure to remove any traces of old gaskets, etc., which may be sticking to the flanges.) The crankcase is checked by placing it on the alignment jig, inserting the ten locating studs in the jig through corresponding bolt holes in the flange of the case. The locating plugs are next inserted through each end of the crankcase into the jig (see Figs. 305 and 306) and the locating pins inserted through both crankcase arms (see Fig. 307). If the alignment of the crankcase is O.K., it will rest evenly on the jig at all points and the locating plugs can be freely inserted into the fixture. If the case does not seat squarely on the jig or if difficulty is experienced in installing the locating plugs, the crankcase is sprung and it will be necessary to straighten it. This is done by striking the high points with a hammer (see Fig. 307) until the crankcase rests squarely on the jig and the locating plugs can be freely inserted into the fixture.

Occasionally a crankcase has been sprung so that it has a tendency to bow either in or out, and as a result difficulty is experienced in attempting to straighten it on the jig. This is due to the fact that when a crankcase is sprung in this manner, it is first necessary to bend it in the opposite direction to which it is sprung and then bring it back to normal from that side in order to prevent it springing out of line again. This, of course, cannot be done on the aligning jig, as the level surface of the fixture prevents bending it below that point.

In an instance of this kind, possibly the simplest method is to straighten the case on an arbor press. This can be done by positioning the crankcase on the press and pressing out

the bowed or raised point, a little at a time, until the crankcase is drawn into line and checks accurately when tested on the aligning jig.

Once in a while a crankcase has been sprung so that the sides of the case where the crank case arms are attached have slightly spread. This condition can be remedied by placing the case in an arbor press and pressing the sides together a little at a time until the case checks accurately on the aligning jig.
